# Manhole Inspection Summary

Manhole # S17I\_\_022MH

Insp Date: **2/27/08 9:25 AM**

**Location** Address: **2 willard st**

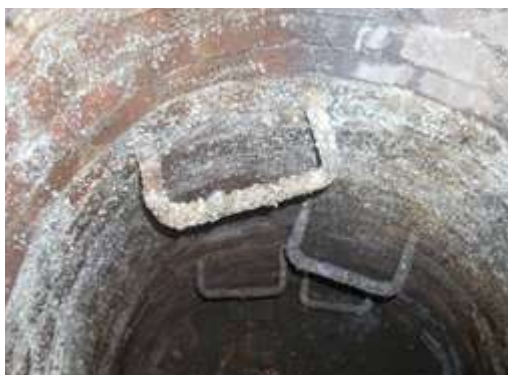
Defect 4

**Surcharge** ☒ Evidence Of Surcharge Depth: **6** (ft.) ☐ Active Surcharge Present

surcharge evidence on the steps and the wall

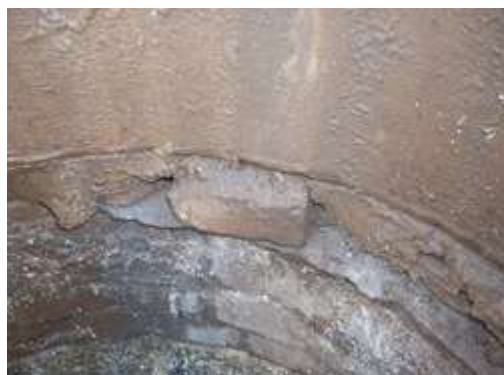
Defect 3

Condition: ☐ Sound ☐ Cracked ☐ Root Intrusion ☒ Loose Brick ☒ Deteriorated

loose chimney bricks

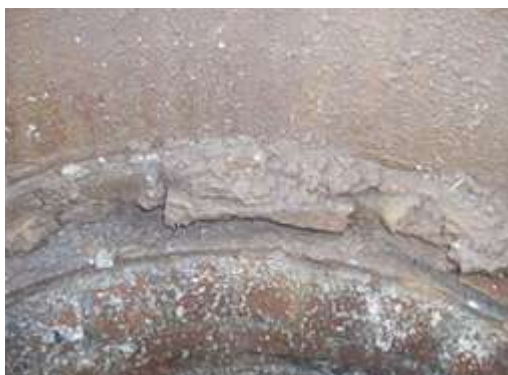
Defect 2

deteriorated chimney

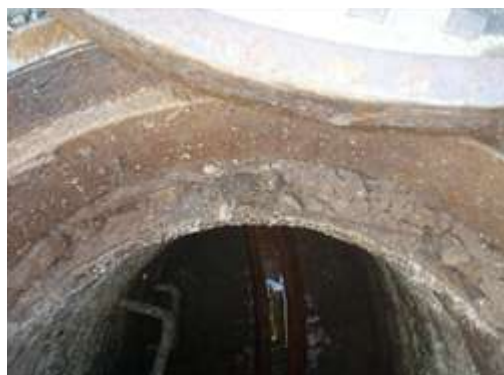
Defect 1

**Frame** Offset: **1** (in.) Condition: ☒ Sound ☐ Cracked ☐ Leaks

frame offset

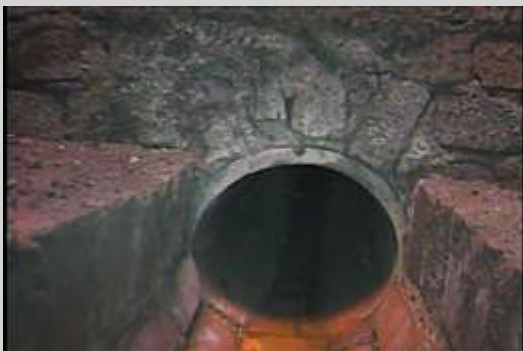
6 O'Clock Inflow

Pipe Height: **8.4** (in.) Rod and Bar (Angled)  
Pipe Material: **Clay** ☐ Pipe Lined  
Invert Depth: **8.07** (ft.) Flow Characteristics: **Slow**  
Deposits: ☒ None ☐ Mud ☐ Sludge ☐ Debris ☐ Grease  
Silt Depth: **0** (in.) Deposits Extent:  
Infiltration: **Evidence** Pipe Seal Cond: **Sound**
